NAWCWD TM8330

**ENGINEERING INVESTIGATION OF FAILURES OF CABLE USED
TO TOW THE TDU-32A BANNER TARGET FROM T2C AIRCRAFT**

by Brent Meeker

6 DEC 2000

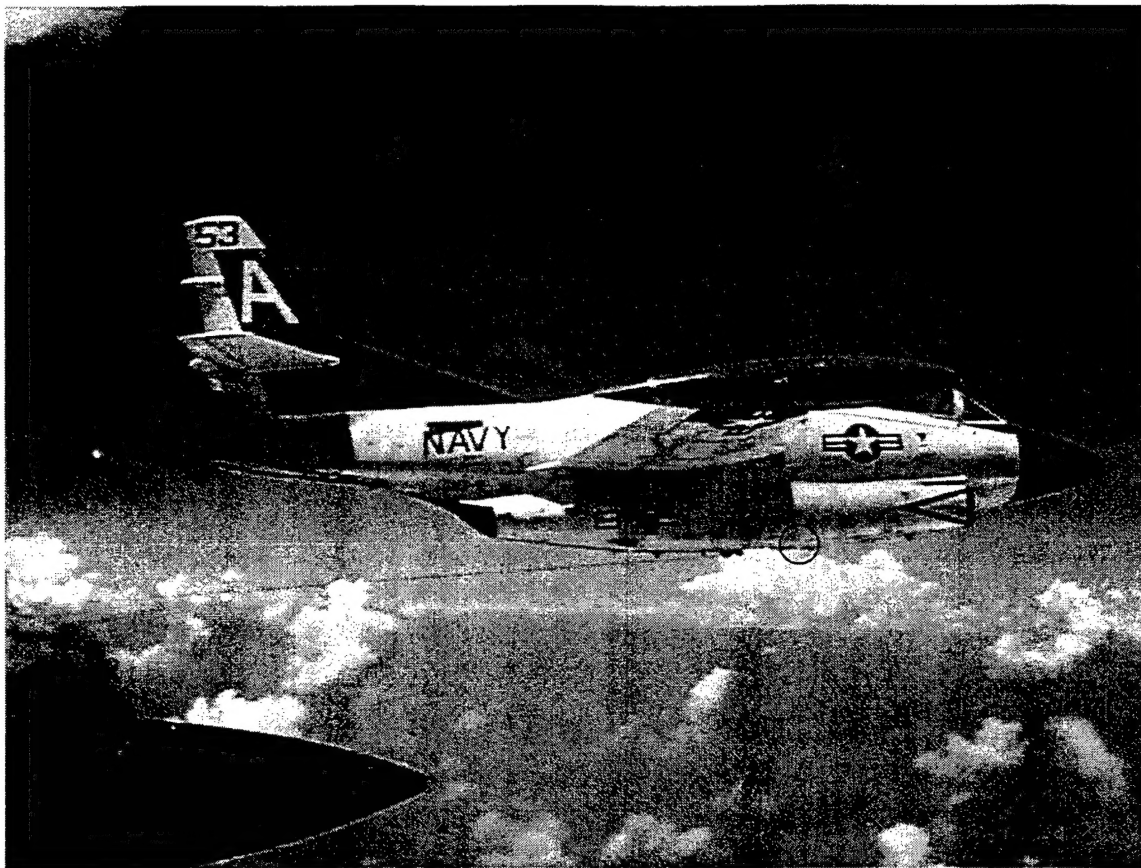
Figure 2. T2C towing a TDU-32A banner in straight and level flight at 15Kft, 200KIAS.

The TDU-32A banner is towed on 800ft of cable. VT-9 uses the North American T2C aircraft. It is the only squadron that uses this aircraft type for banner towing. The attachment point for the tow cable is on the centerline of the aircraft 13.6ft forward of the exhaust plane as shown in figure 2.

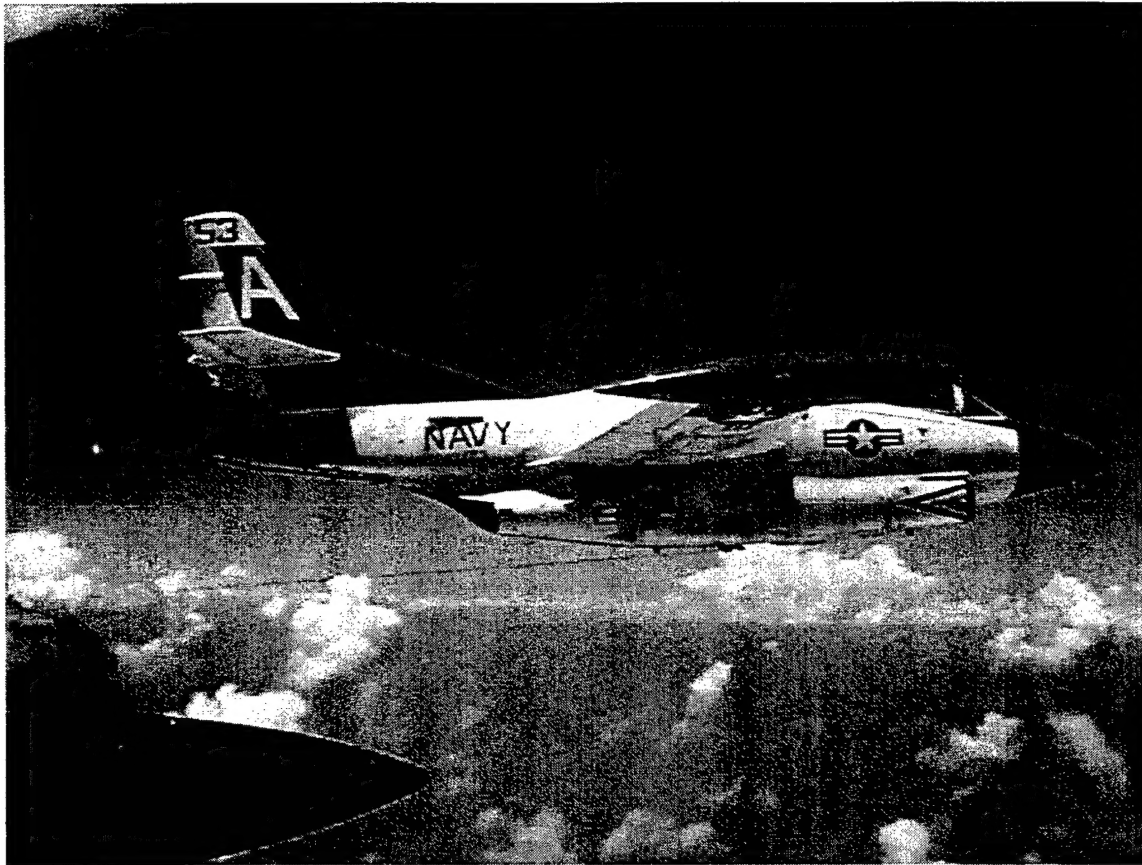
Scaling from figure 2, the tow point is 13.3ft forward of the exhaust on the center-line of the belly. This photograph was taken a 200KEAS in straight and level flight. At this flight condition, the bottom of the exhaust opening is seen to be 0.58ft above the tow point.
